RC
1042
.M38
1990a
c.2

Department
of Transportation
National Highway
Traffic Safety
Administration

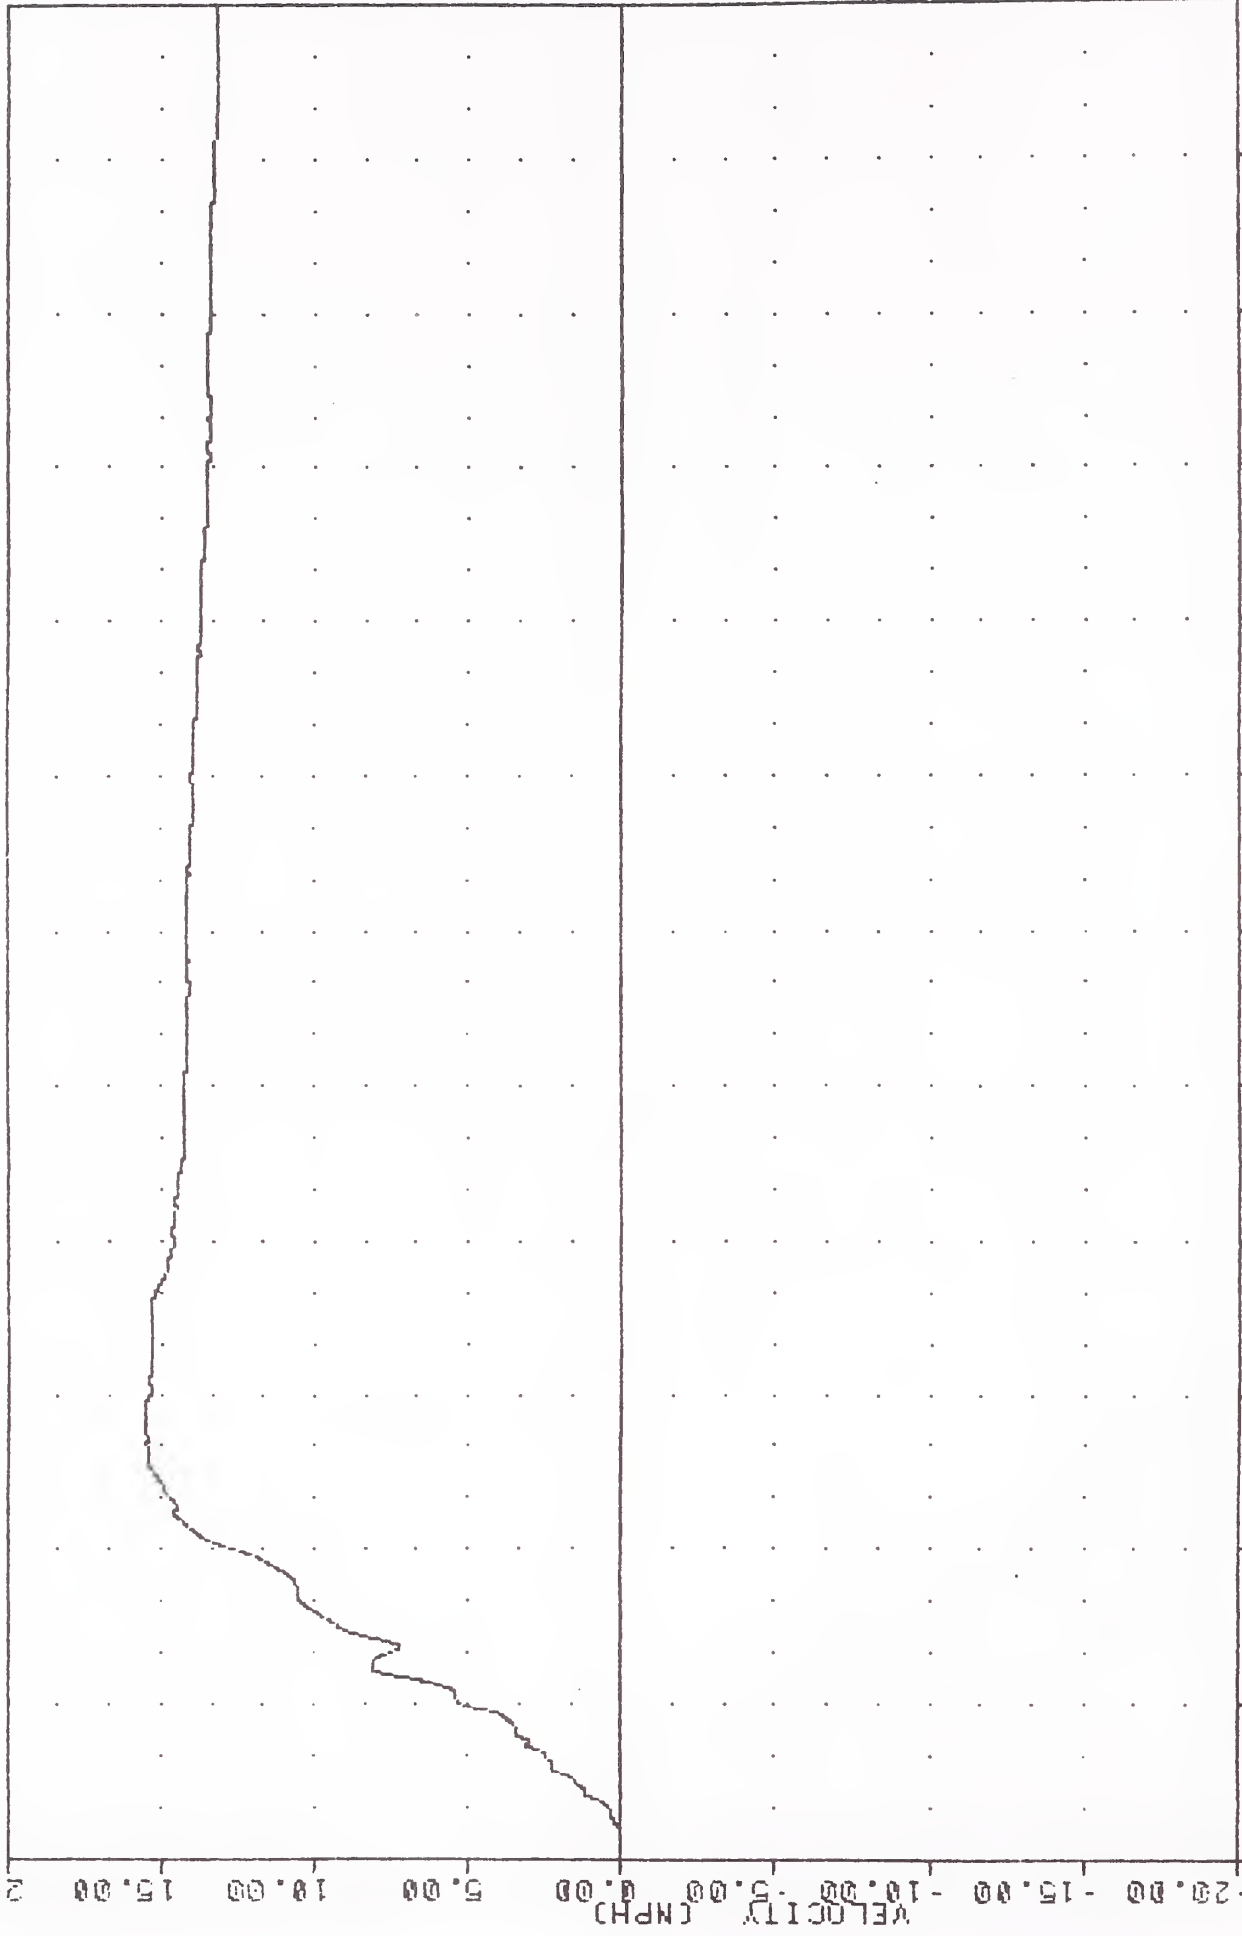
0.00 28.33 56.66 85.00 113.33 141.66 170.00 198.33 226.66 255.00 283.33 311.66 340.00
 TIME (MSEC)
 CONTOURED MOVING BARRIER INTO FORD ESCORT AT 28.1 MPH #2
 VEHICLE CG RESULTANT VELOCITY

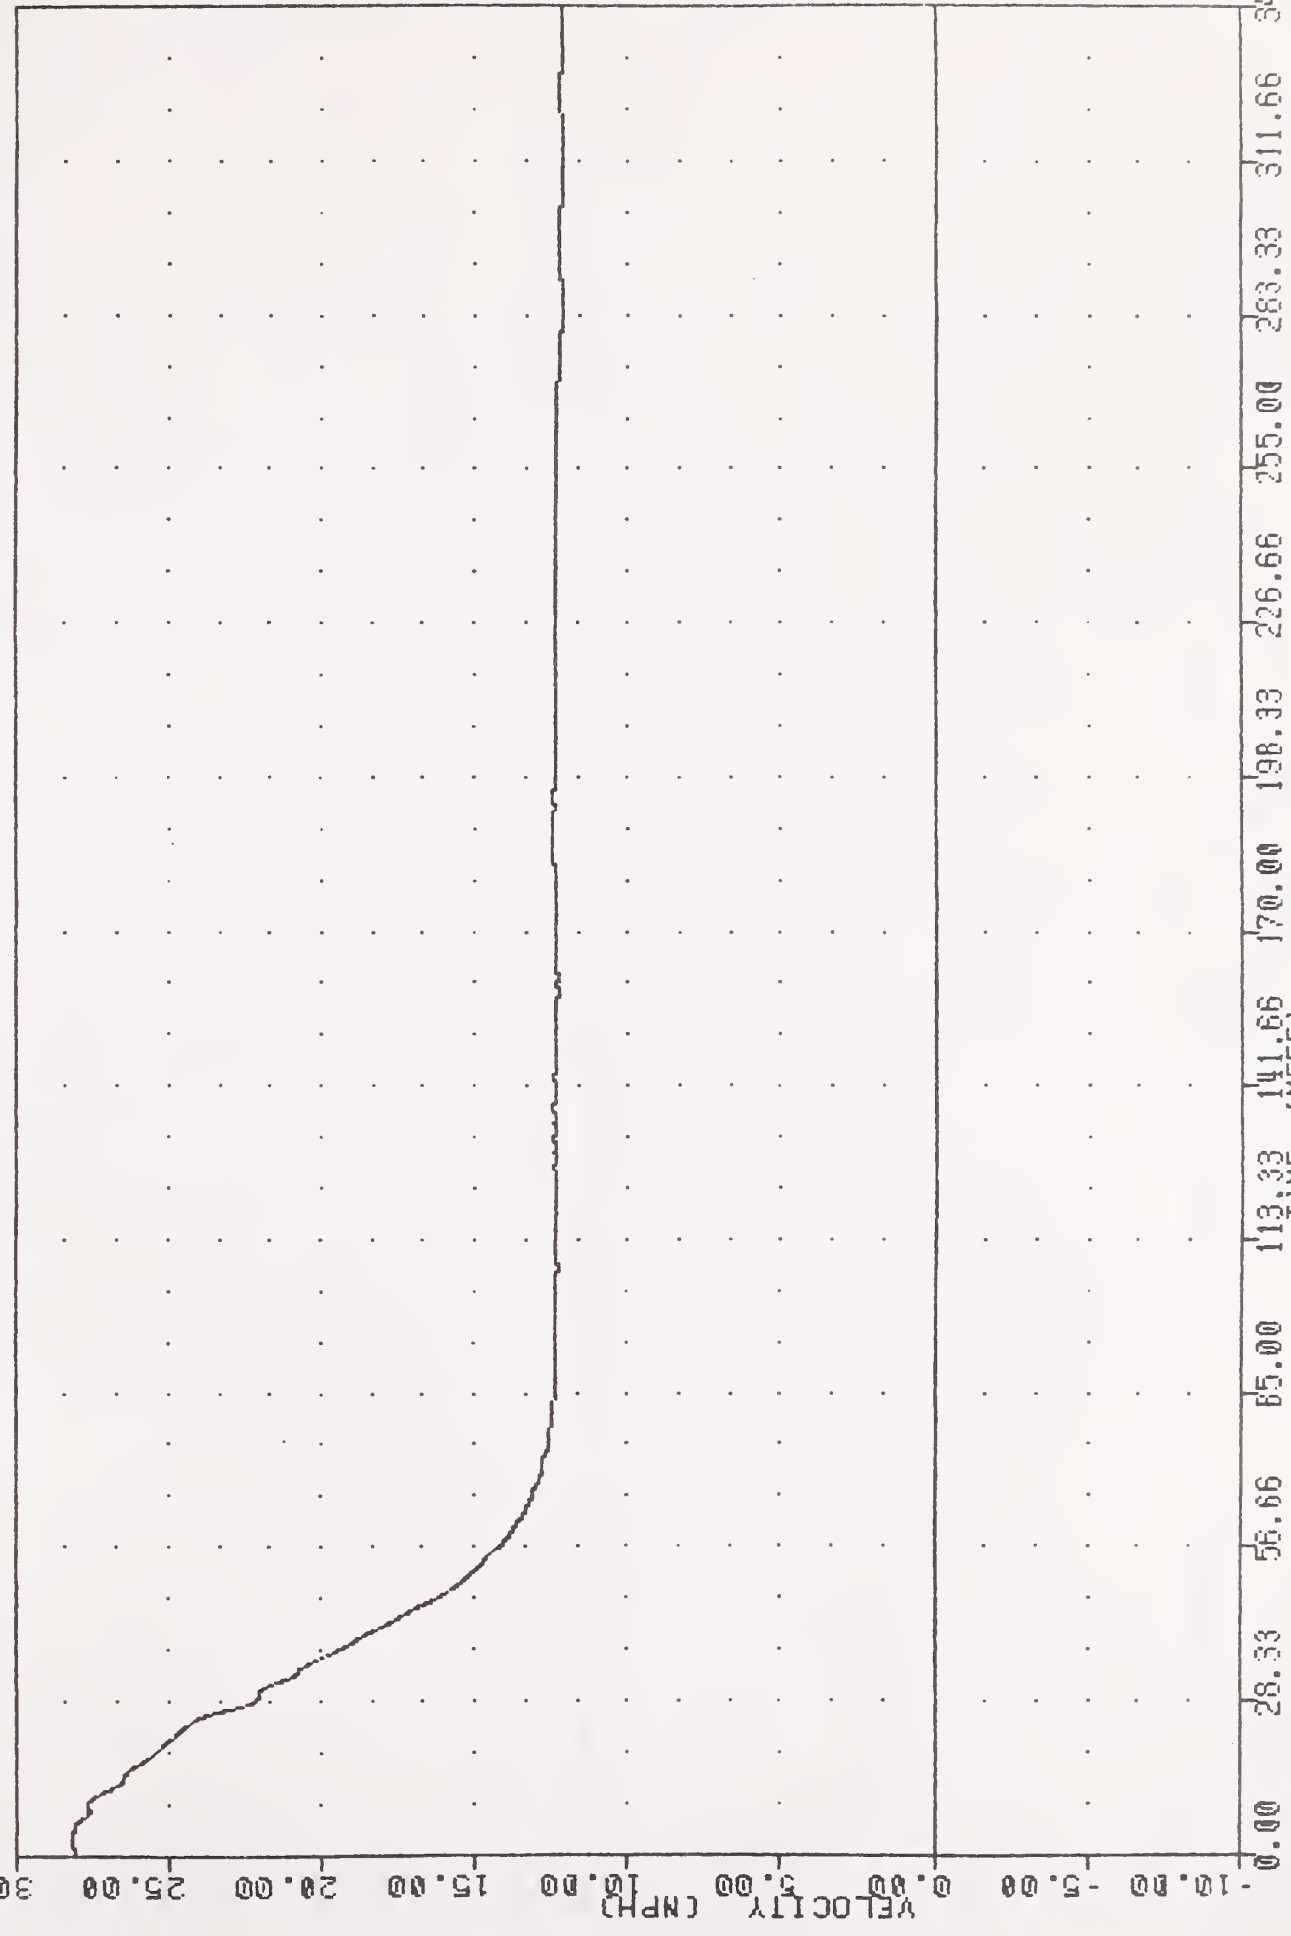
CONTOURED MOVING BARRIER INTO FORD ESCORT AT 28.1 MPH *2
 MOVING BARRIER CENTER OF GRAVITY X-AXIS VELOCITY

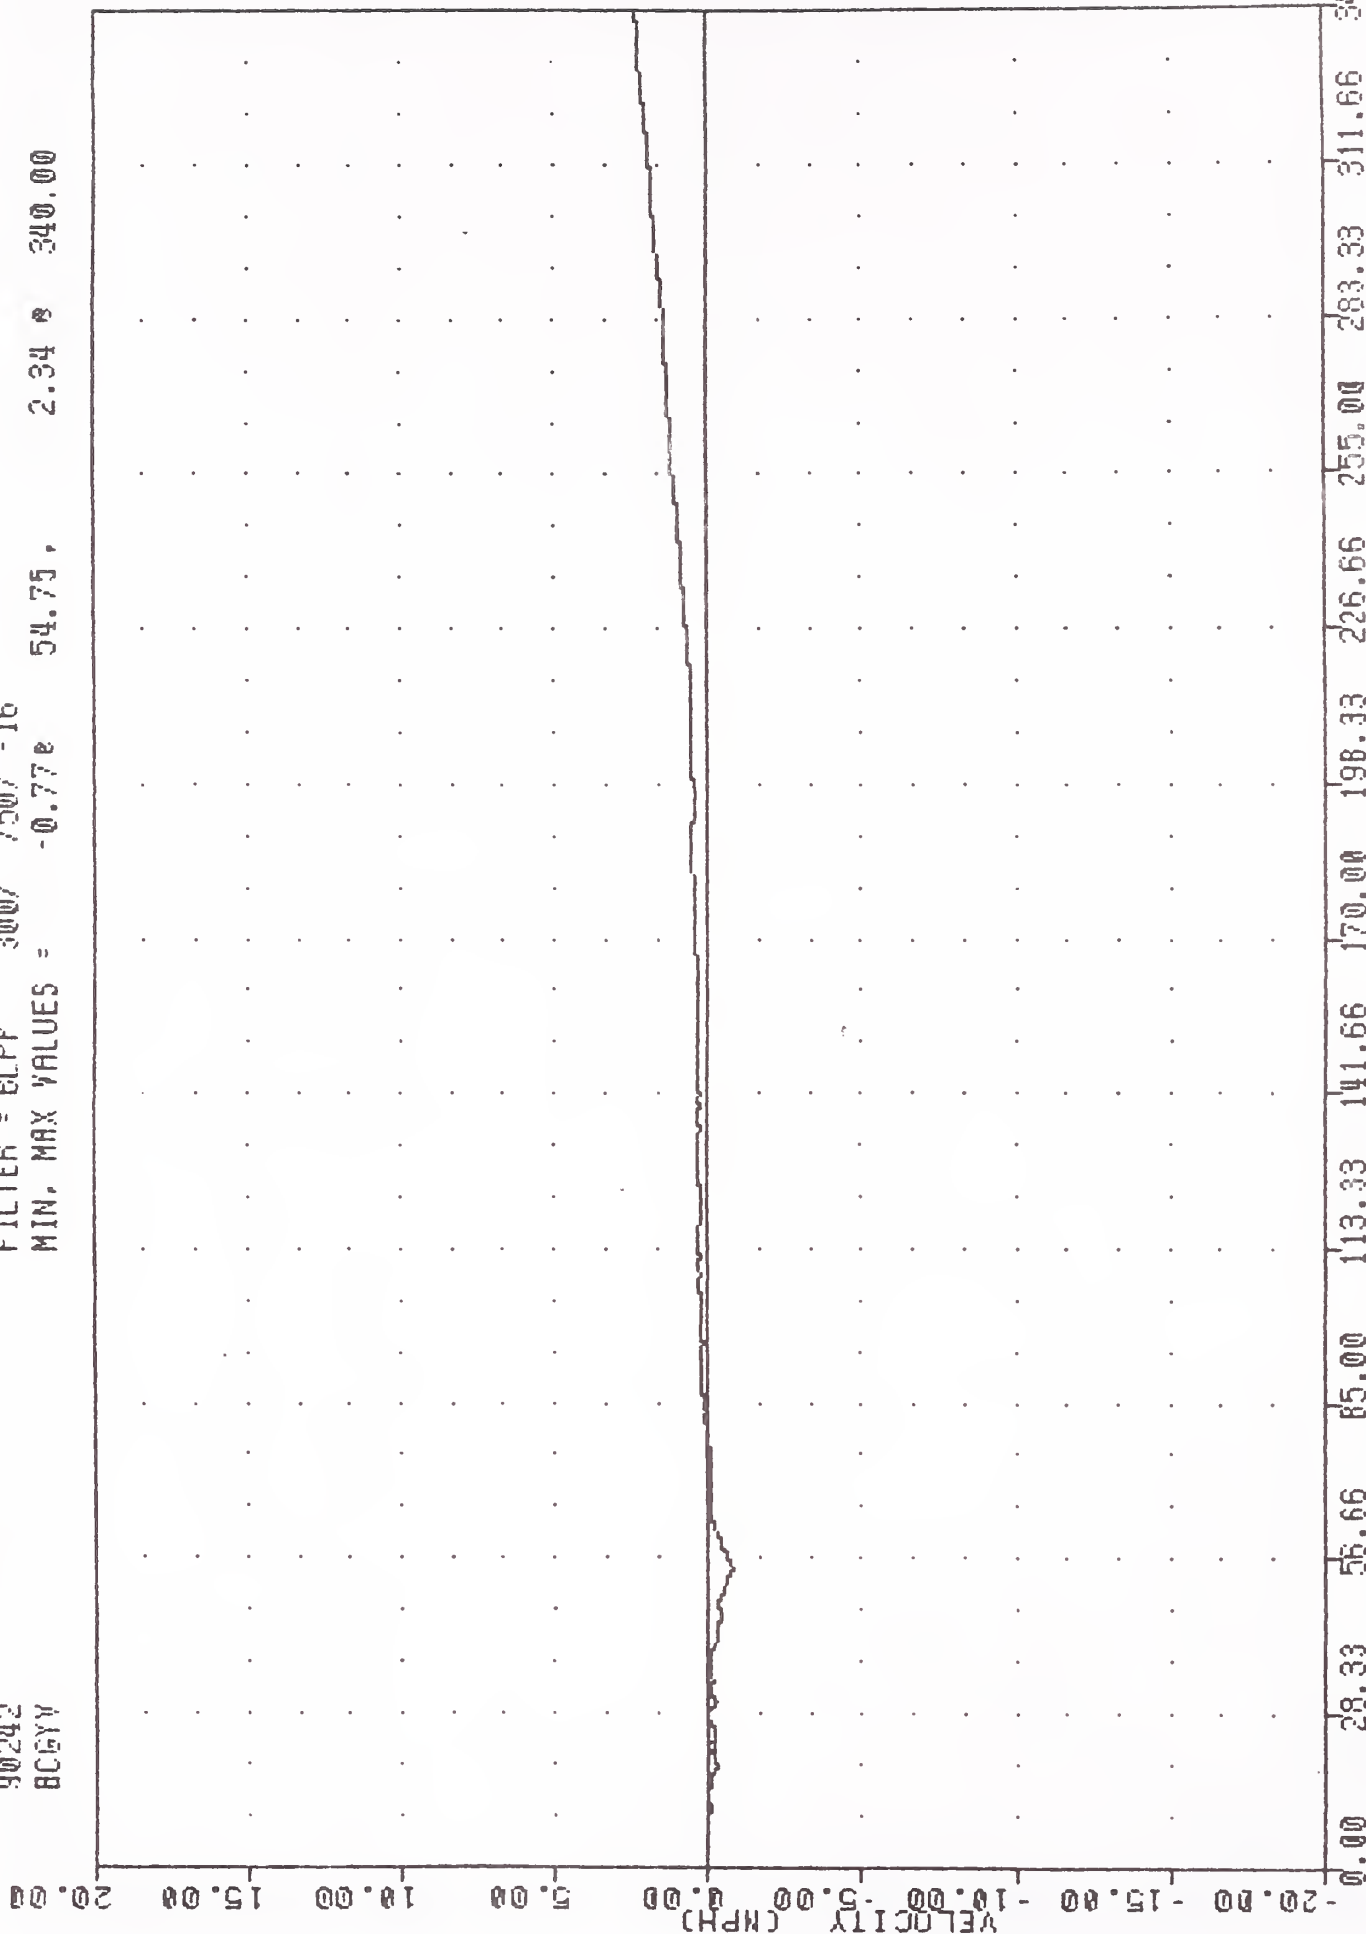
CONTOURED MOVING BARRIER INTO FORD ESCORT AT 28.1 MPH #2
 MOVING BARRIER CENTER OF GRAVITY Y-AXIS VELOCITY

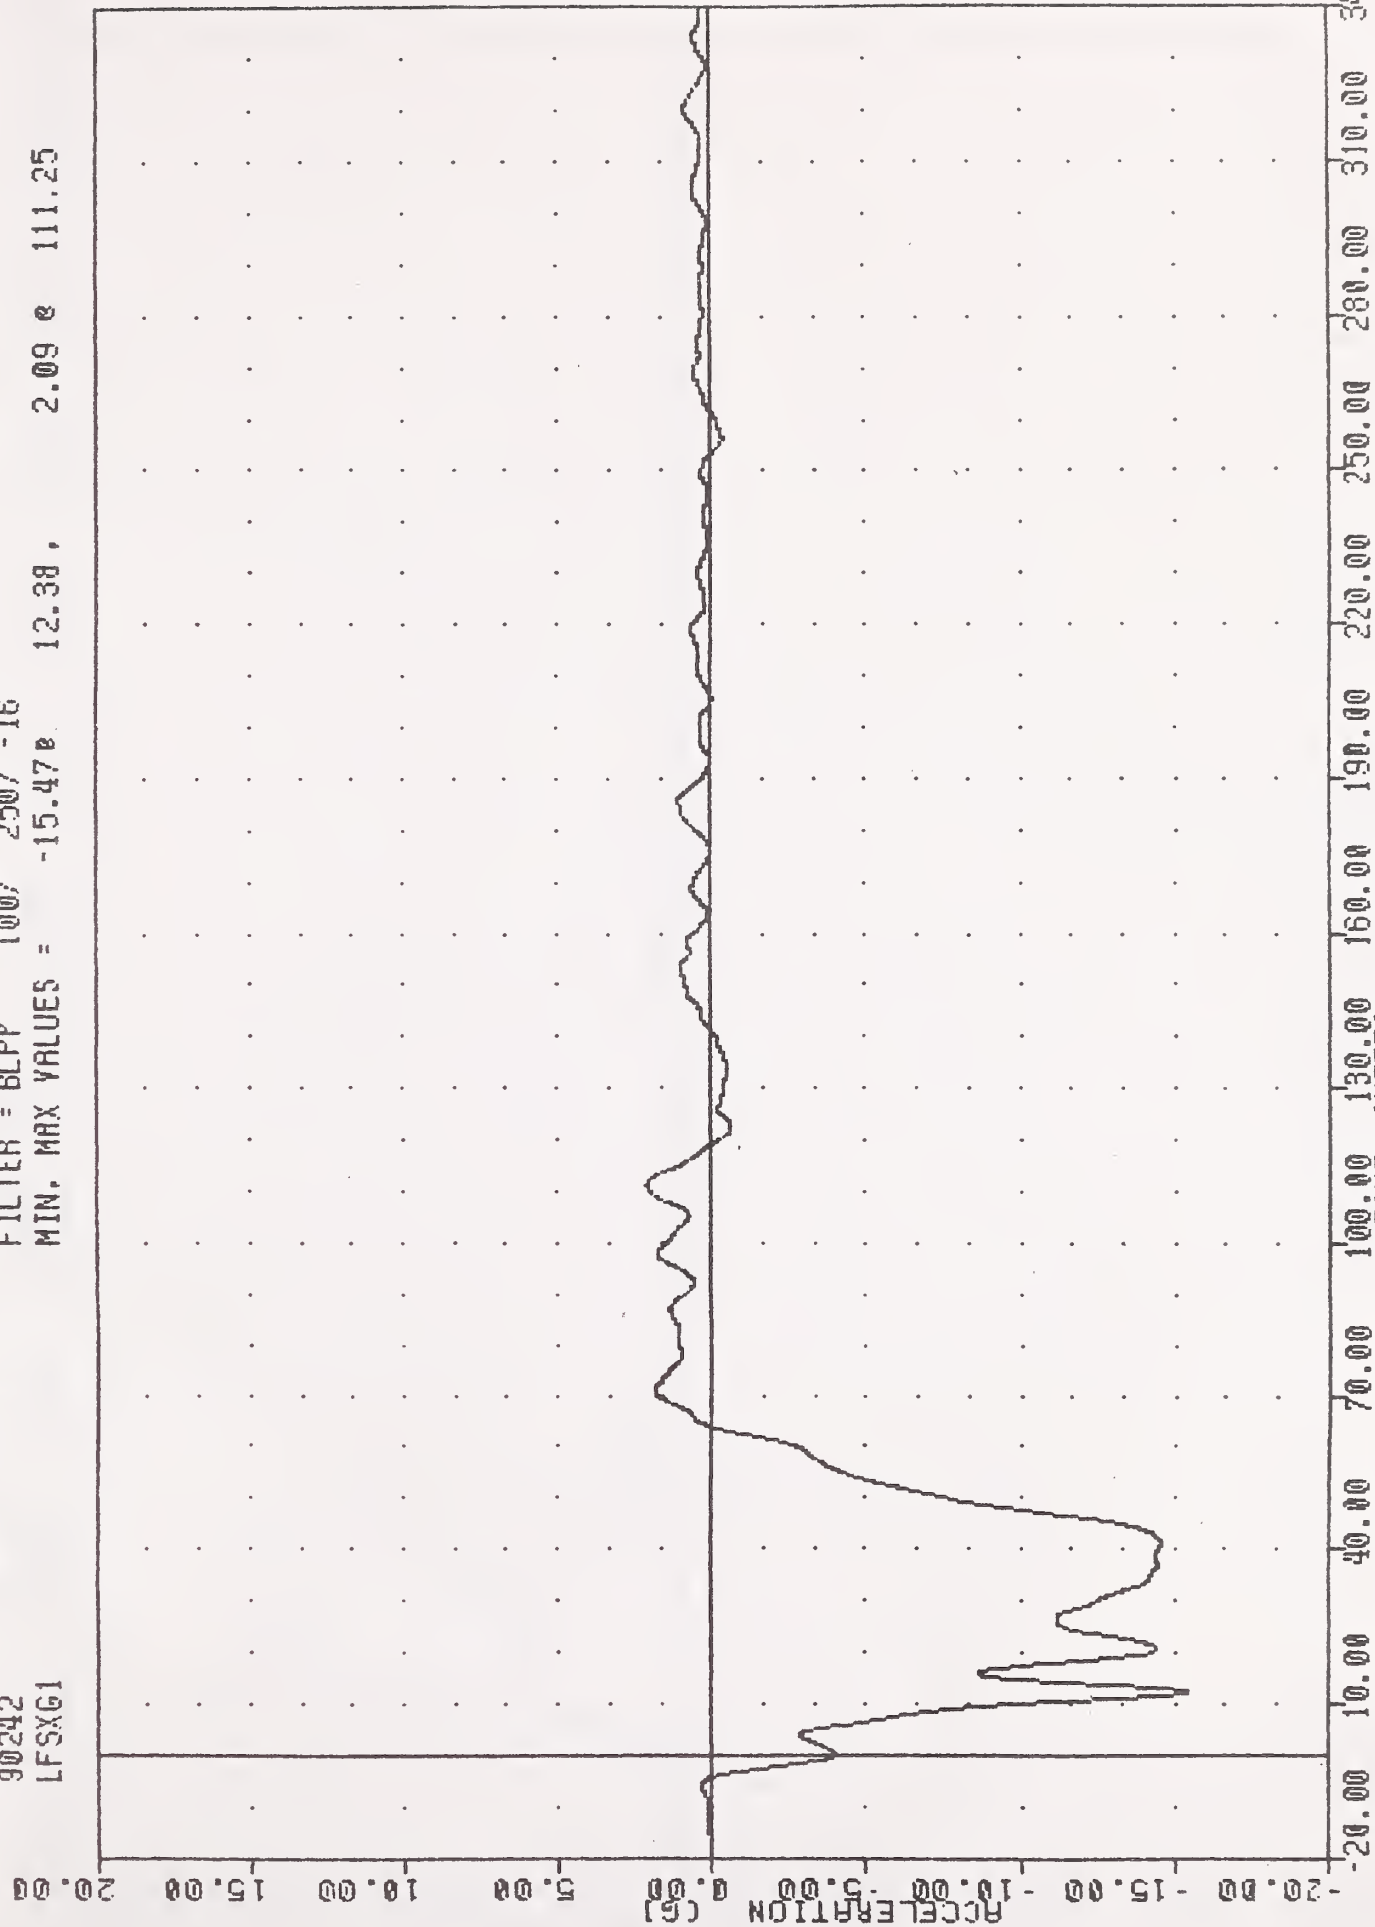
CONTOURED MOVING BARRIER INTO FORD ESCORT AT 28.3 MPH *3
LEFT FRONT SILL X-AXIS ACCELERATION

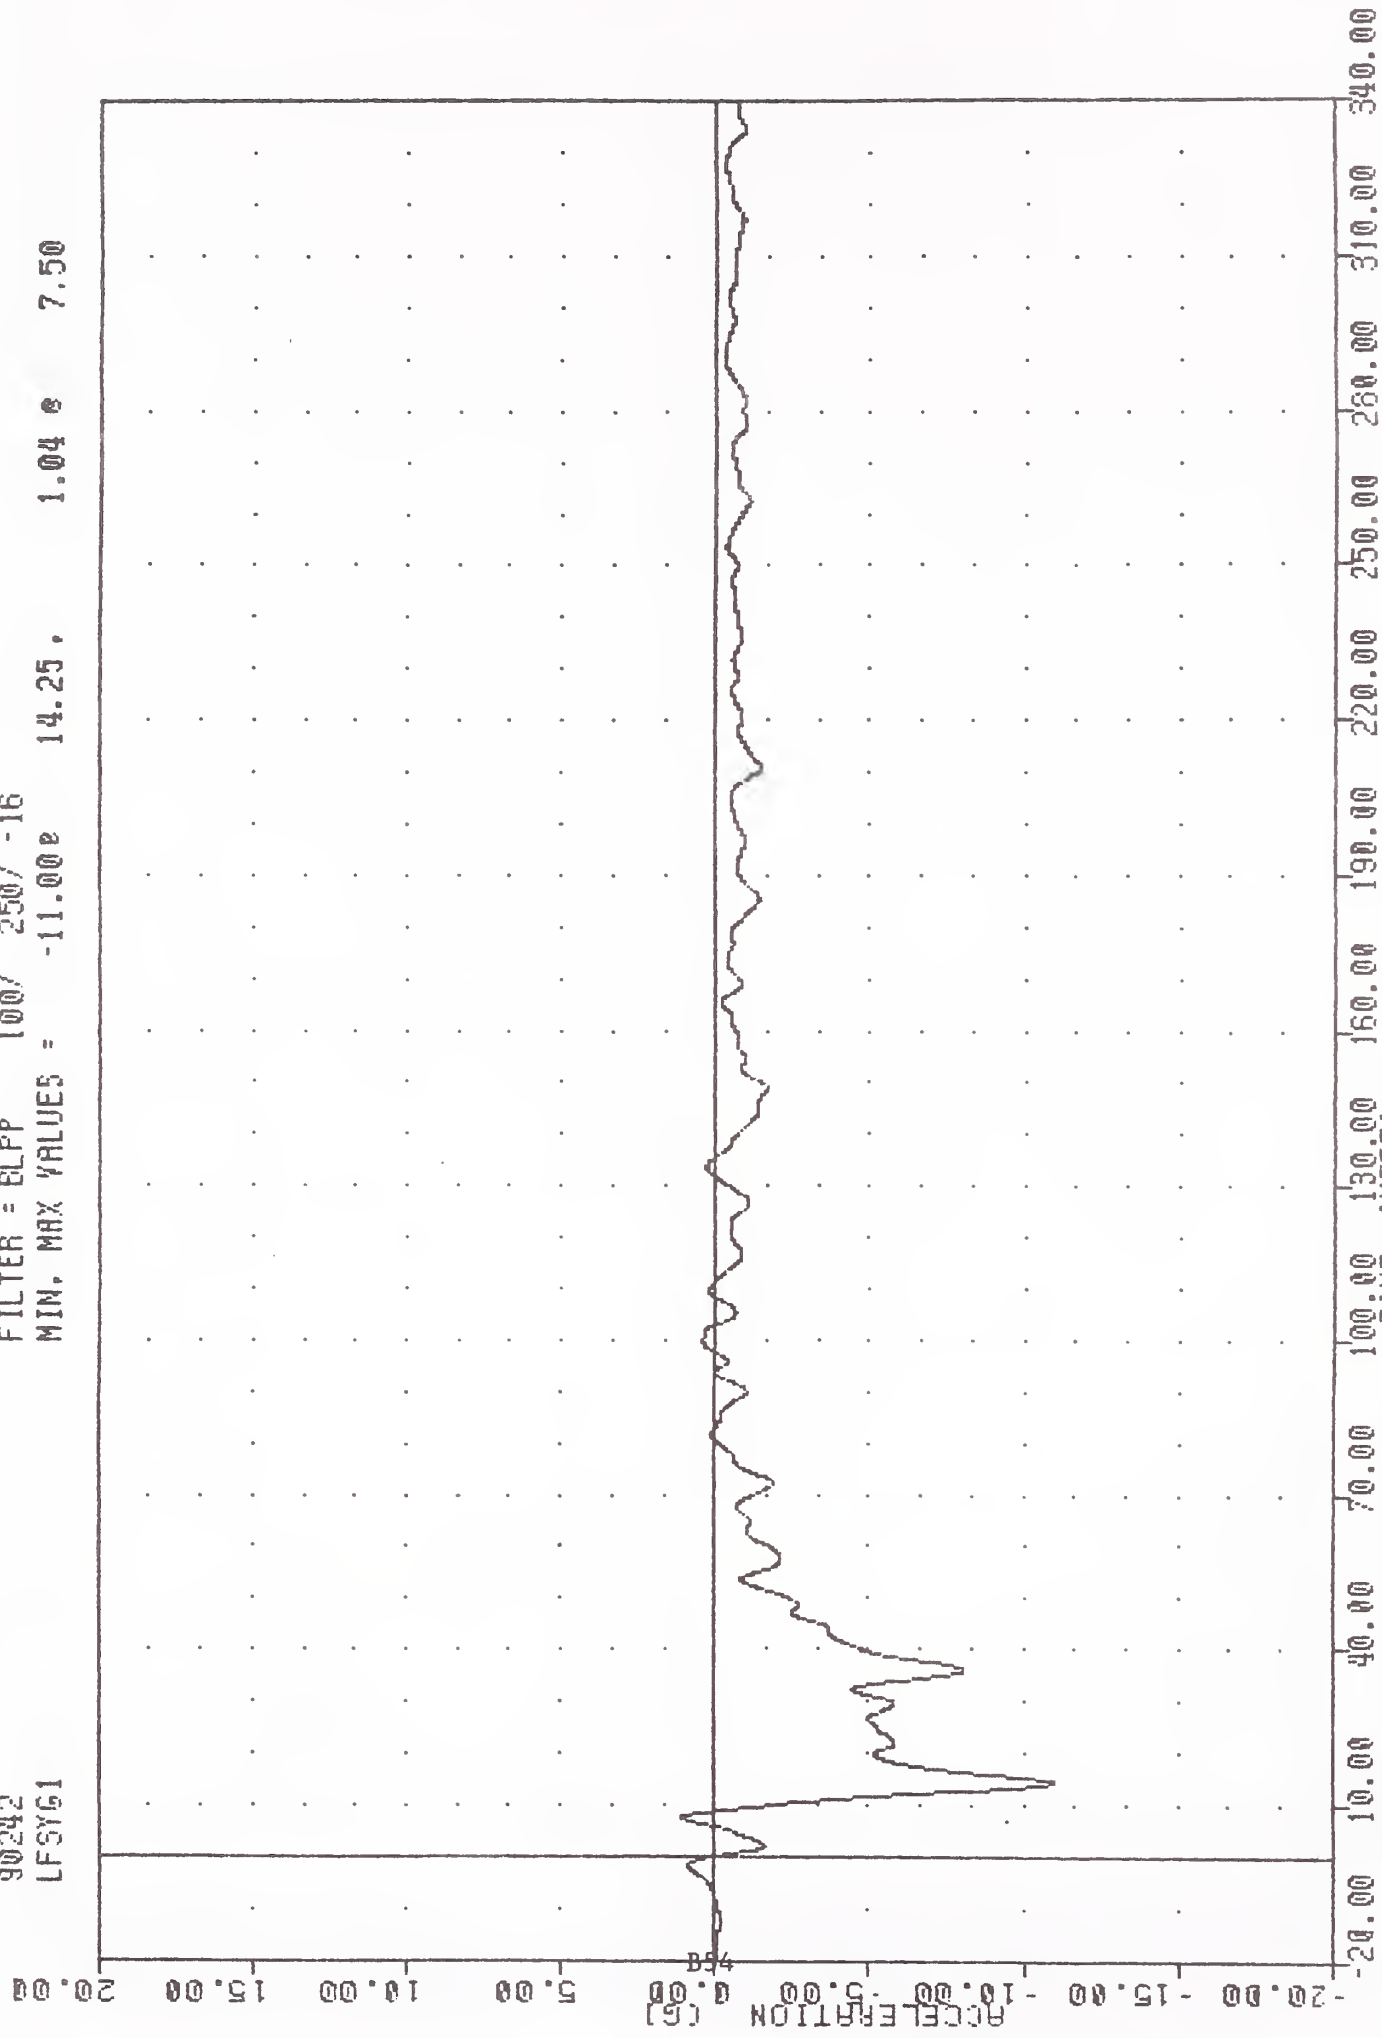
CONTOURED MOVING BARRIER INTO FORD ESCORT AT 28.3 MPH #3
LEFT FRONT SILL Y-AXIS ACCELERATION

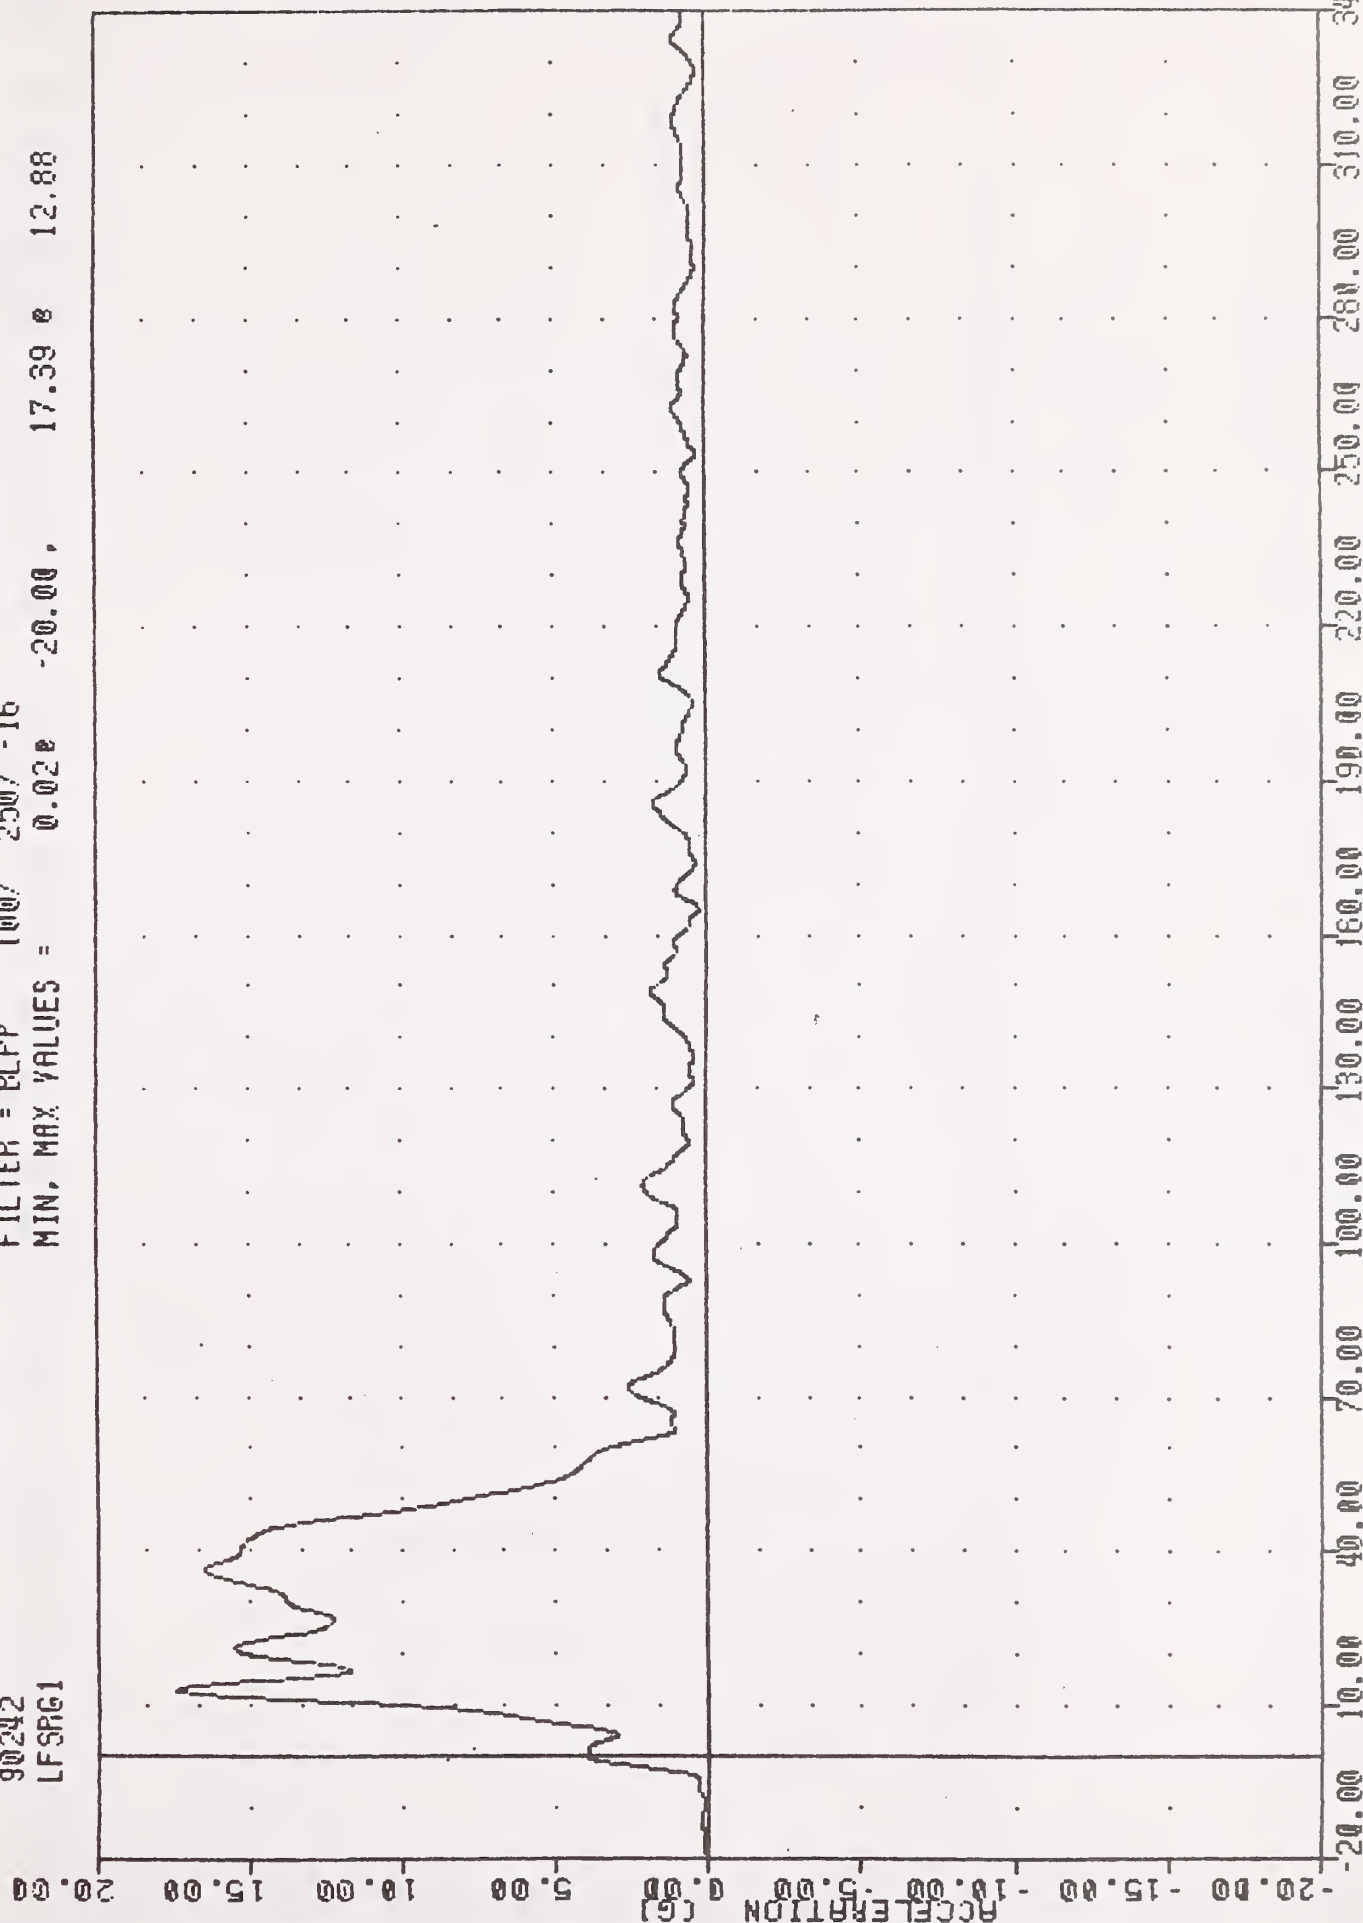
CONTOURED MOVING BARRIER INTO FORD ESCORT AT 28.3 MPH #3
LEFT FRONT SILL RESULTANT ACCELERATION

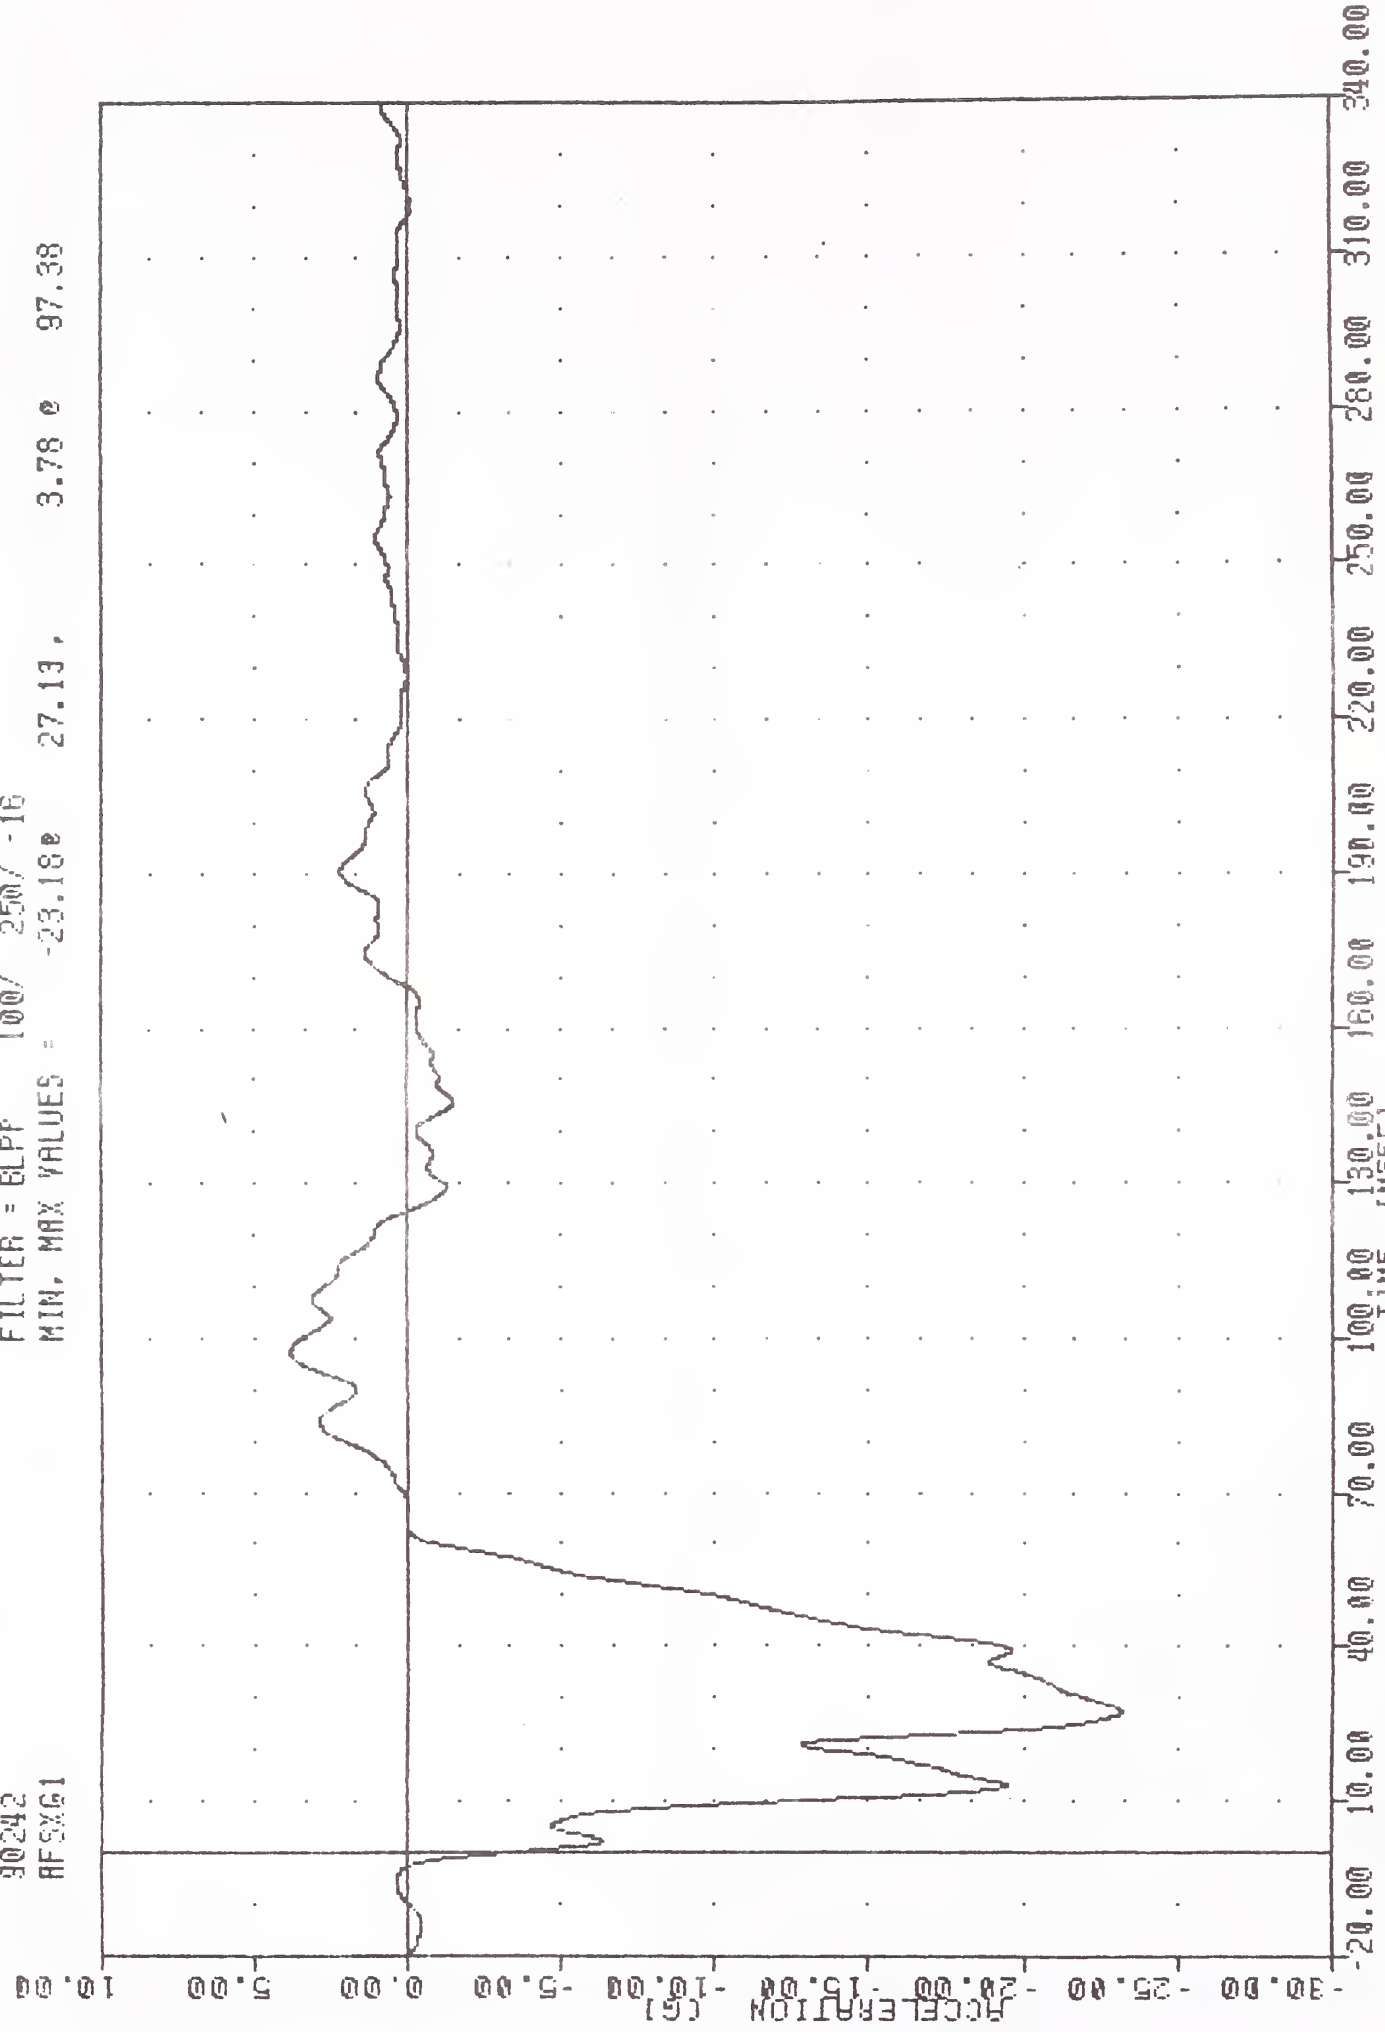
CONTOURED MOVING BARRIER INTO FORD ESCORT AT 28.3 MPH #3
 RIGHT FRONT SILL X-AXIS ACCELERATION

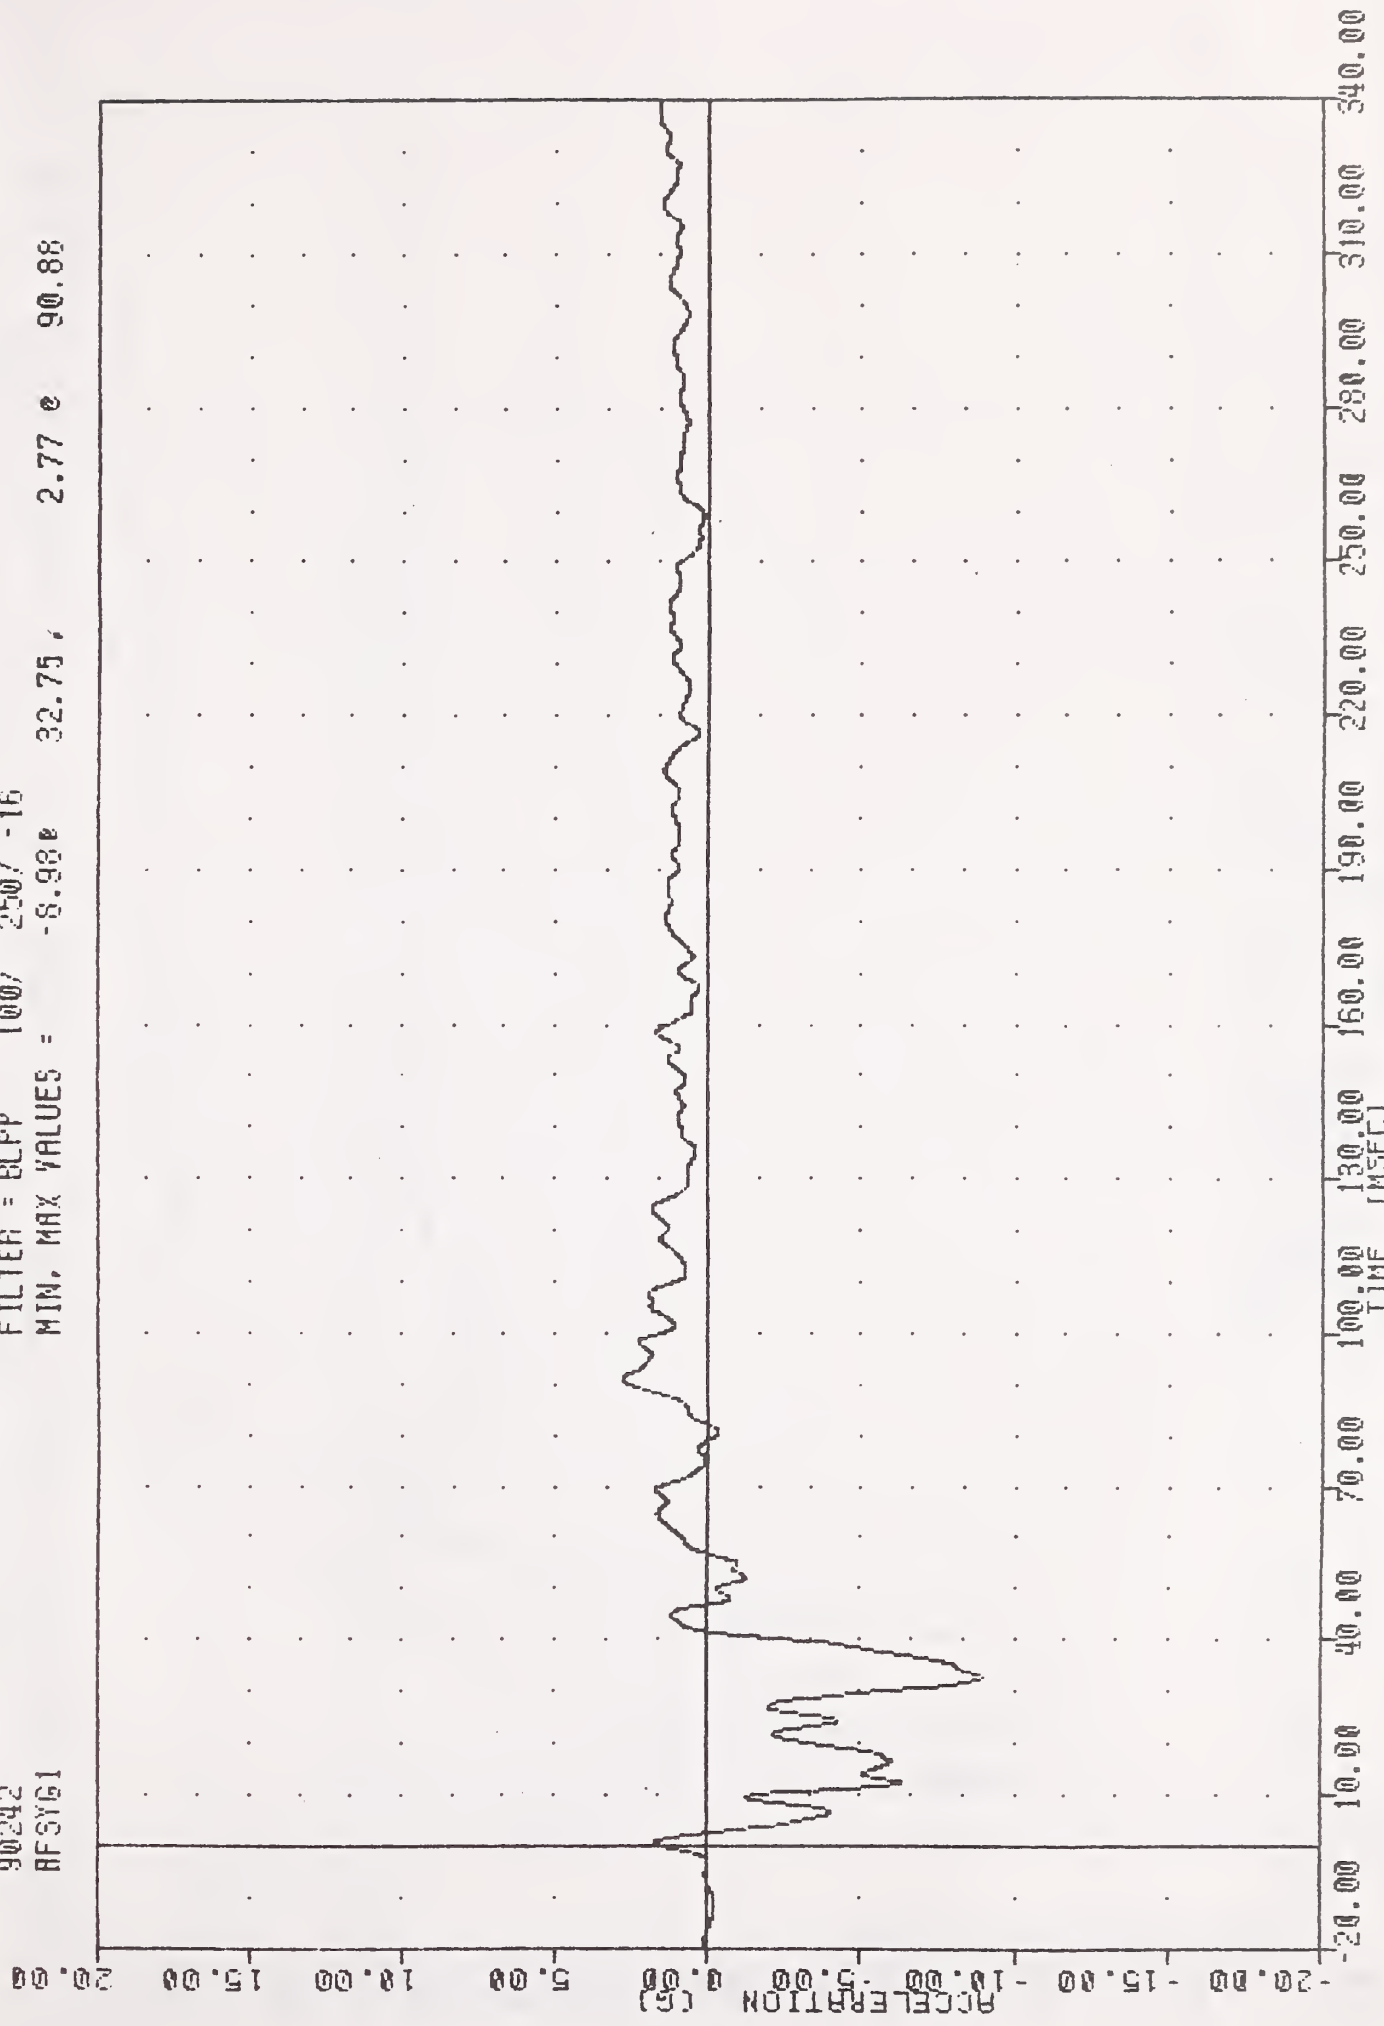
CONTOURED MOVING BARRIER INTO FORD ESCORT AT 28.3 MPH #3
RIGHT FRONT SILL Y-AXIS ACCELERATION
